HIGHER MAGNIFICATION IMAGING OF THE POLISHED ALUMINUM COLLECTOR RETURNED FROM THE GENESIS MISSION. M. C. Rodriguez¹, P. J. Burkett², J. H. Allton³; ¹Geocontrol Systems- ESCG at NASA/Johnson Space Center, Houston, TX 77058; melissa.rodriguez-1@nasa.gov, ² Jacobs- ESCG at NASA/Johnson Space Center, Houston, TX 77058, ³ NASA/Johnson Space Center, Houston, TX 77058.

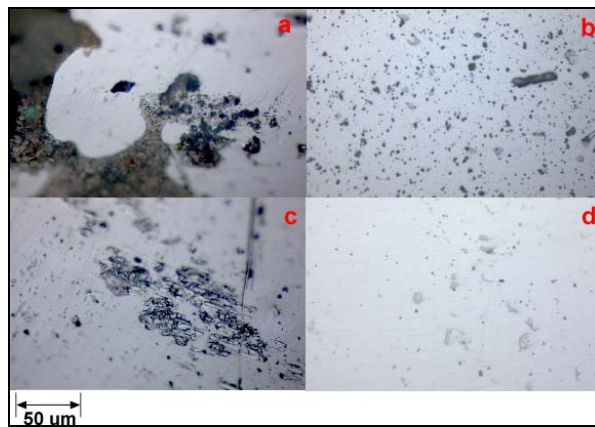
scanned at 5X magnification on a Leica DM6000M microscope using either Surveyor or Image Pro Plus software. Under higher magnification, the post-landing aluminum surface is very uneven, with many bumps and undulating ridges (Fig.2a). There are also several depressions that appear as microcraters on initial examination. Portions of these “pits” have angular walls and shallow, irregular depths; excluding them from consideration as hypervelocity impact craters. Much of the contamination observed under higher magnification is consistent with what is seen on the majority of the Genesis collector array materials: 1) dark carbon fibers and fragmented array collector fines, such as silicon dust, from the spacecraft and 2) Utahogenic particulate dispersion of salts and sediments, including dried droplets (Fig.2b). Several gouges and scratches are also seen (Fig.2c). There is one feature unique to the polished aluminum surfaces: the presence of small, transparent, irregularly shaped gray film-like specks seen at 50X. They are seen on each kidney subsample and are randomly distributed across the surface (Fig. 2d).

Fig. 2a-d. Examples of surface contamination on the polished aluminum pieces found at 50X magnification
