RECENT OPTICAL AND SEM CHARACTERIZATION OF GENESIS SOLAR WIND CONCENTRATOR DIAMOND-ON-SILICON COLLECTOR. J. H. Allton¹, M. C. Rodriguez², P. J. Burkett³, D. K. Ross³ and C. P. Gonzalez³ and K. M. McNamara¹, ¹NASA/Johnson Space Center, 2101 NASA Parkway, Mail Code KT, Houston, TX 77058, USA, Judith.h.allton@nasa.gov, ²ESGC Geocontrol Systems- ESCG at NASA/JSC, ³Jacobs- ESCG at NASA /JSC.

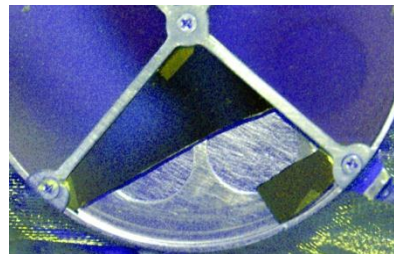
Description of collector 60000: Fig. 1 shows the largest piece of the concentrator DOS collector, as recovered in Utah. This piece was located at the focal point of the concentrator; thus, having the greatest concentration of solar ions. Additionally, this piece had two areas inadvertently not covered by the carbon coating and, thus exposing the silicon to capture solar ions. The exposed silicon, set up a potential opportunity to measure solar carbon. Fig. 2 shows sample 60000 prior to subdivision.

Fig. 1. False color image of DOS collector fragment 60000 mounted in frame and location of frame shadow. Green areas show solar-wind-exposed silicon.

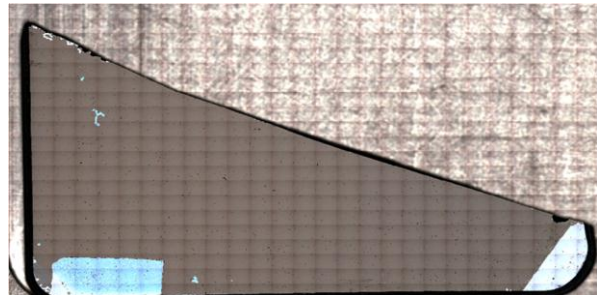
Fig. 2. Fragment 60000 color-enhanced to show increased blueness of silicon areas near focal point, presumably due to irradiation. The bright areas are silicon, called “heel” and “toe” of sock shape.

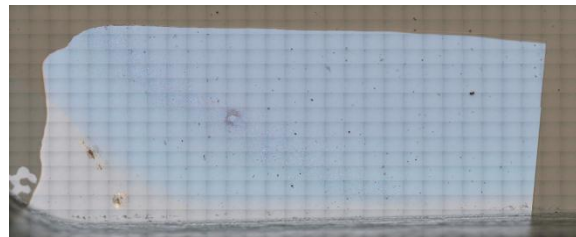
Typical post-landing particulate contamination. Optical imaging of 60000 reveals glass microsphere shards and carbon fibers (both return capsule structural materials), dried droplets, miscellaneous fibers, smears and particles. Near the frame attachments, on the silicon “heel” and “toe” surfaces, smears of gold-colored material are noted (Figs. 3 & 4). A brief survey of related fragment, 60737, was undertaken via SEM (JEOL 7600F). Most abundant particles were gold (with nickel and/or aluminum) and GaZnAl-oxide bearing paint. Less abundant particles consisted of silicate glass, germanium metal, stainless steel, and terrestrial soil.

Fig. 3. Silicon “heel” showing frame shadow and gold-colored smears.

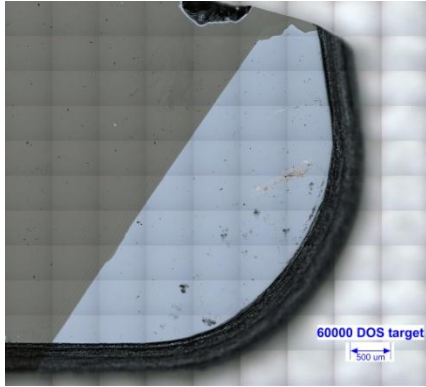
Fig. 4. Silicon "toe" showing gold-colored smear and debris.

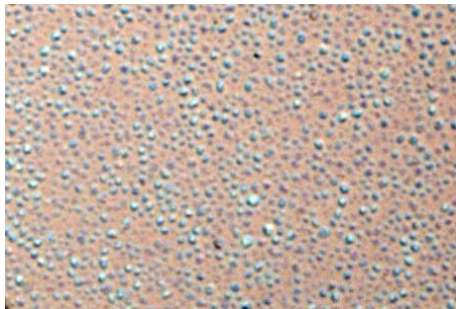
Evidence of irradiation damage near focal point silicon. Optical imaging revealed a correlation of “blueness” and presence of bubble texture (Fig. 5). No gradient was noted across “heel”. Bubble texture is not observable on “toe”. Estimated flux gradient is 20X near focal point vs 6X near outer radius (Wiens, personal communication).

Fig. 5. Bubble texture on blue areas of silicon. Bubble features are micrometer diameter.

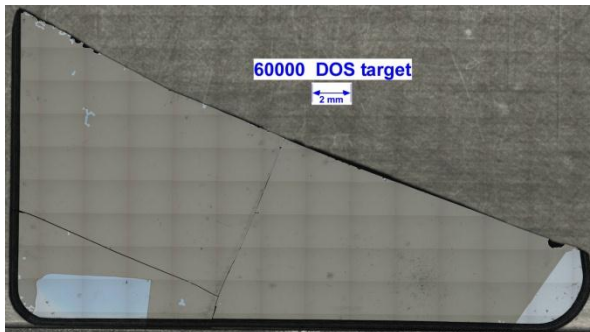
Fig. 6. Post-subdivision solar wind surface.

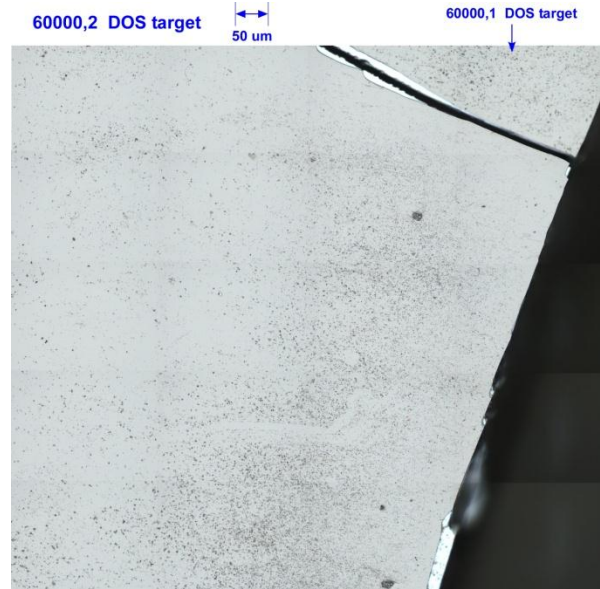
Imaging after subdivision: Fig. 6 shows solar wind surface after subdivision by laser scribe/cleaving. The subdivision process [4, 5] produces silicon/silicon oxide debris which gets onto the solar wind surface (Fig. 7) and needs to be removed. Further imaging of the subdivided surfaces is in progress.

Fig. 7. Subdivision process debris added near edges.
