Genesis Mission Bulk Metallic Glass Solar Wind Collector: Characterization of Return Samples Available for Re-Allocation. C. P. Gonzalez¹, K. K. Allums², J. H. Allton³, R. Harrington¹, L. Le¹, and K. Thomas-Keprta¹, ¹Jacobs, NASA Johnson Space Center, Houston, TX 77058, ²HX5- Jacobs JETS Contract, NASA Johnson Space Center, Houston, TX 77058, ³NASA Johnson Space Center, Houston, TX 77058

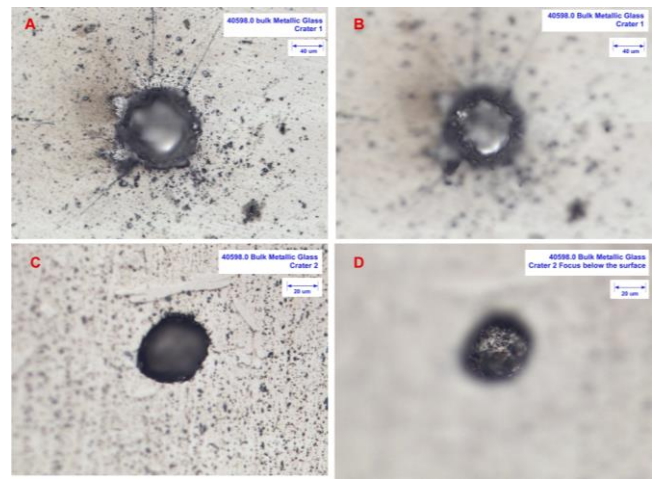
Recent work: The BMG parent piece was imaged using optical through-focus imaging to produce several two-dimensional images of a three-dimensional object. This imaging method was used to observe possible crater-like features shown in Figures 3 & 4. For example, in Fig. 3 two possible craters, designated as 1 & 2, are shown. Both in focus images, or those taken at the uppermost surface of the feature, and images taken at or near a possible crater floor, are shown. Possible crater 1 is ~90-100 μm in diameter (\varnothing). Possible crater 2 is ~40-50 μm \varnothing .

Fig. 3. A) Possible crater 1 with the optical image focused at the uppermost surface. B) Possible crater 1 optical image focused below the surface, near a purported crater floor. C) Possible crater 2 optical image focused at the uppermost surface. D) Possible crater 2 image focused below the surface, near a purported crater floor.

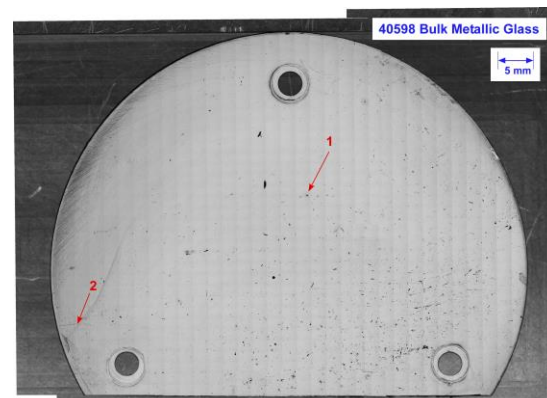
Fig. 4. Optical image taken of BMG 40598.0. Red arrows point to possible craters 1 & 2.

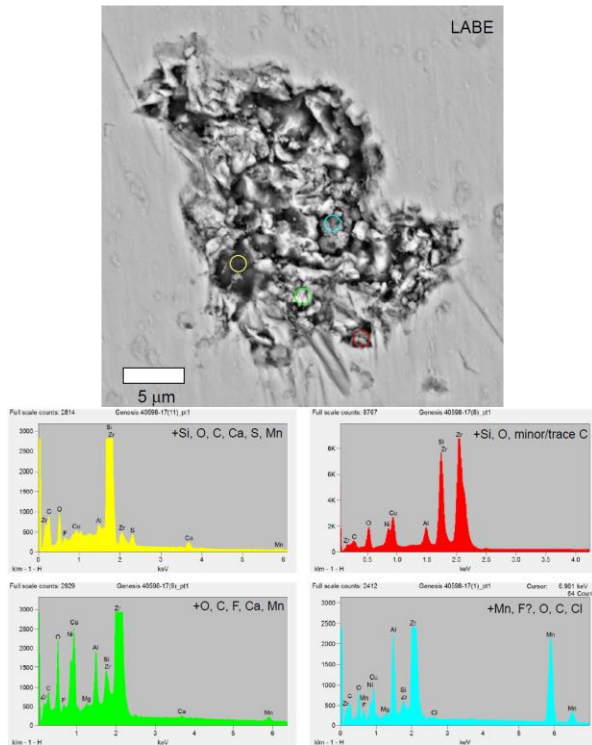
Fig. 5. *Top*: FESEM/low angle backscatter electron image of an intriguing feature, $\sim 15 \times 25 \mu\text{m}$, in sample 40598.17. This feature may be interpreted as a low velocity impact feature or corrosion behavior of a BMG. Circles designate regions of interest (ROIs) analyzed using energy dispersive X-ray spectrometry (EDX; 15 kV/sample uncoated). *Bottom*: Four EDX spectra of ROIs located within the feature. They are color coordinated with the circles in the upper view. The BMG is composed of Zr, Cu, Ni, Al & Nb. Additional elements detected in the feature include C, O, Si, Mn & F resulting from a possible impact event or corrosion behavior of the BMG during the reentry crash.

High magnification optical microscopy revealed semi-circular, μm -size features subsequent to characterization using field emission scanning electron microscopy (FESEM) on samples 40598.13, 40598.16, 40598.17, and 40598.35. No features were interpreted as possible craters with one exception in 40598.17 (Fig. 5). This feature *may be* interpreted as a possible low velocity impact crater or is consistent with corrosion behavior of the BMG substrate exposed to the Utah soil. The presence of elements within the void not associated with the background/BMG matrix pose an intriguing question as to the origin of this feature. Unfortunately the BMG surface has many voids and scratches likely acquired during reentry and crash landing.
