**ENHANCED CLEANING OF GENESIS SOLAR WIND SAMPLE 61348 FOR FILM RESIDUE REMOVAL.** K. K. Allums, C. P. Gonzalez<sup>2</sup>, K. R. Kuhlman<sup>3</sup>, J. H. Allton<sup>4</sup> <sup>1</sup>HX5,LLC-Jacobs JETS Contract, NASA Johnson Space Center, Houston, TX 77058, <sup>2</sup>Jacobs, NASA Johnson Space Center, Houston, TX, 77058, <sup>3</sup>Planetary Science Institute, Tuscon, AZ 85719;kim@psi.edu, <sup>4</sup>NASA Johnson Space Center, Houston, TX 77058

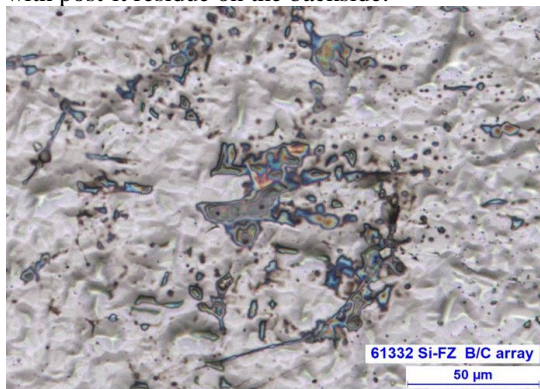
**Post-it Residue Contamination:** Post-it residue was noticed on two flight samples after routine UPW wafer spinner cleaning. Observation of the backside of 12 different samples indicated a film-like material only on those samples transported on post-its (Fig. 1) after mission recovery. Figure 1 below shows sample 61332 with post-it residue on the backside.

**Figure 1:** Post –it residue on Backside of 61332

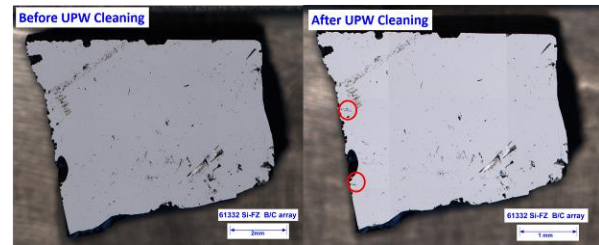
The suspected post-it adhesive, once transferred to the front-side(solar wind side) by UPW proved to be difficult to remove with UPW, hot xylene, and aqua regia [2]. Figures 2 and 3 show a film-like residue was transferred from the back of sample 61332 to the front side.

**Figure 2:** Post-it Residue After UPW in Red Circles

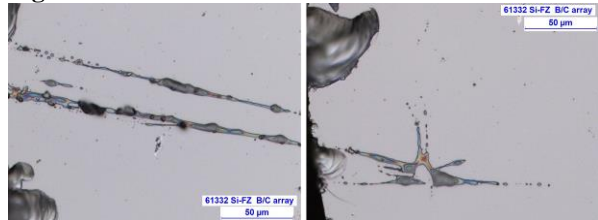
**Figure 3:** 50X image of the transferred Post-it residue.

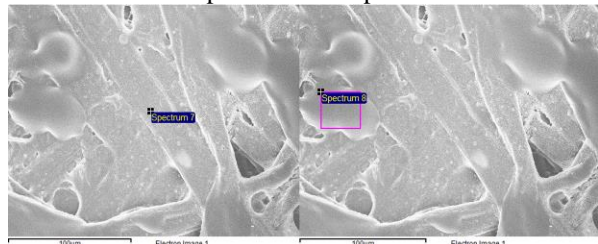
**Figure 4:** SEM images of EDX spectrum locations.

In the EDX spectra, the adhesive appears to have Al in it in addition to C and O (spectrum 8) and the “fibers” (spectrum 7) of the post-it also show a Si peak to be present. Based on the information presented, the best option would be to dissolve the post-it residue off the sample completely to prevent redeposition to the front of the sample during standard UPW cleaning with our wafer spinner system.

For this reason we've had the composition of the post-it residue analyzed with SEM and EDX to identify the individual components of the post-it adhesive.

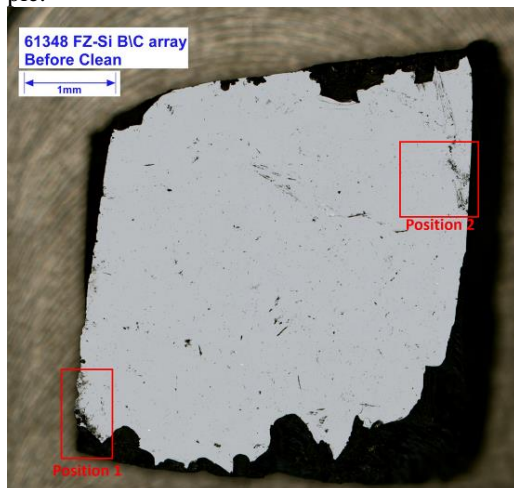
A flight sample was selected from the Si flight inventory that was initially placed on a post-it note when recovered from the Utah Landing site. The sample was imaged and investigated for signs of post-it residue on the front and back of the sample. Two positions of interest were imaged at 50X with a Leica DM6000M microscope to track the cleaning process. (Fig.5 boxed in red) The following steps performed on Flight Sample 61348 were:

Figure 5: Flight sample 61348 before cleaning.

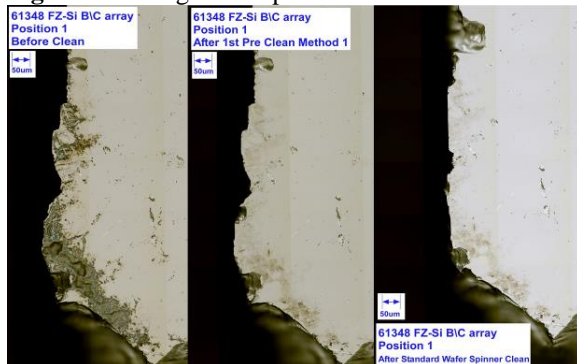
Figure 6: Before and After Cleaning of Position 1

Once all cleaning was completed the images show significant removal of the post-it residue as well as other particulate contamination. However, on the front of the sample in the positions of interest it seems some shadowing or hard to remove post-it residue remains. Observations of the backside of the sample show the added advantage of the submersive Pre-Cleaning Method removes particulate debris as well as post-it residue.

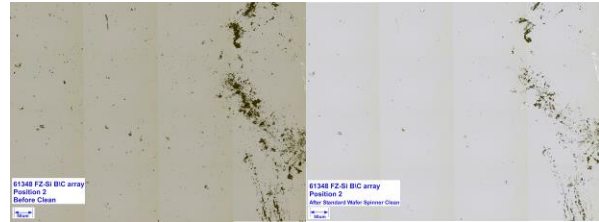
Figure 7: Shows Position 2 before and after cleaning.

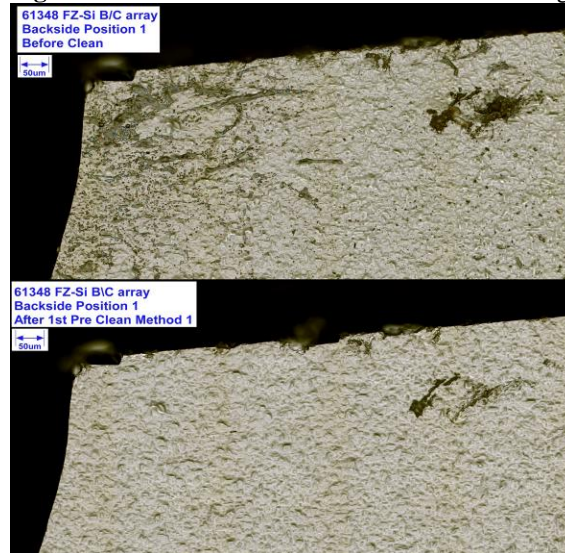
Figure 8: Backside of 61348 before and after Pre-Clean

**Conclusions:** The Genesis Pre-Clean Method 1 removes significant post-it residue contamination as well as particulate debris from the Utah landing site on both the front and back of the sample and minimizes the probability of redepositing the adhesive or debris on the front of the sample. As shown in figure 8 the backside of the sample is virtually cleaned of all post-it note residue. Future work to use other solvents along with IPA and UPW to clean Genesis samples are in progress. However an approved clean laboratory without the chemistry restrictions of Genesis Curation Laboratory will have to be used.
