Genesis Mission Bulk Metallic Glass Solar Wind Collector: Characterization of Return Samples Available for Re-Allocation. C. P. Gonzalez¹, K. K. Allums², J. H. Allton³, R. Harrington¹, L. Le¹, and K. Thomas-Keprta¹, ¹Jacobs, NASA Johnson Space Center, Houston, TX 77058, ²HX5- Jacobs JETS Contract, NASA Johnson Space Center, Houston, TX 77058, ³NASA Johnson Space Center, Houston, TX 77058

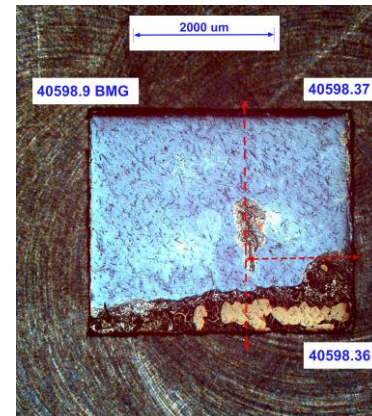
Fig. 6. Red dash line shows the cutting path followed to subdivide sample 40598.9

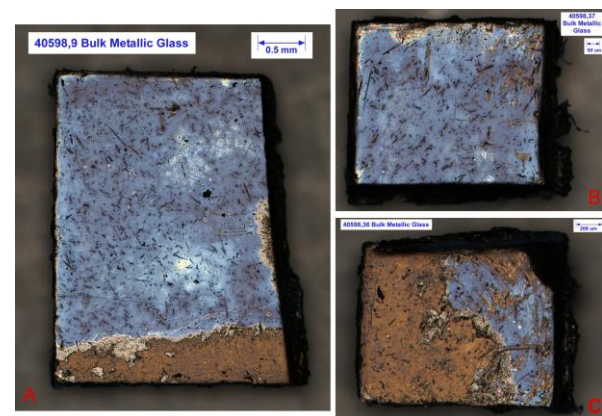
blade. Subdivision plan and final sample images are shown in Figs. 6 & 7. The partial devitrification of the BMG is visible in most optical images of the subsamples and is also evident in FESEM images.

Fig. 7. Sample image taken after subdivision with a diamond blade. A) Sample 40598.9 B) Sample 40598.37 C) Sample 40598.36
